INDOOR AIR QUALITY ASSESSMENT

**Ralph B. O'Maley Middle School
32 Cherry Street
Gloucester, Massachusetts**

Prepared by:
Massachusetts Department of Public Health
Center for Environmental Health
Emergency Response/Indoor Air Quality Program
March 2006

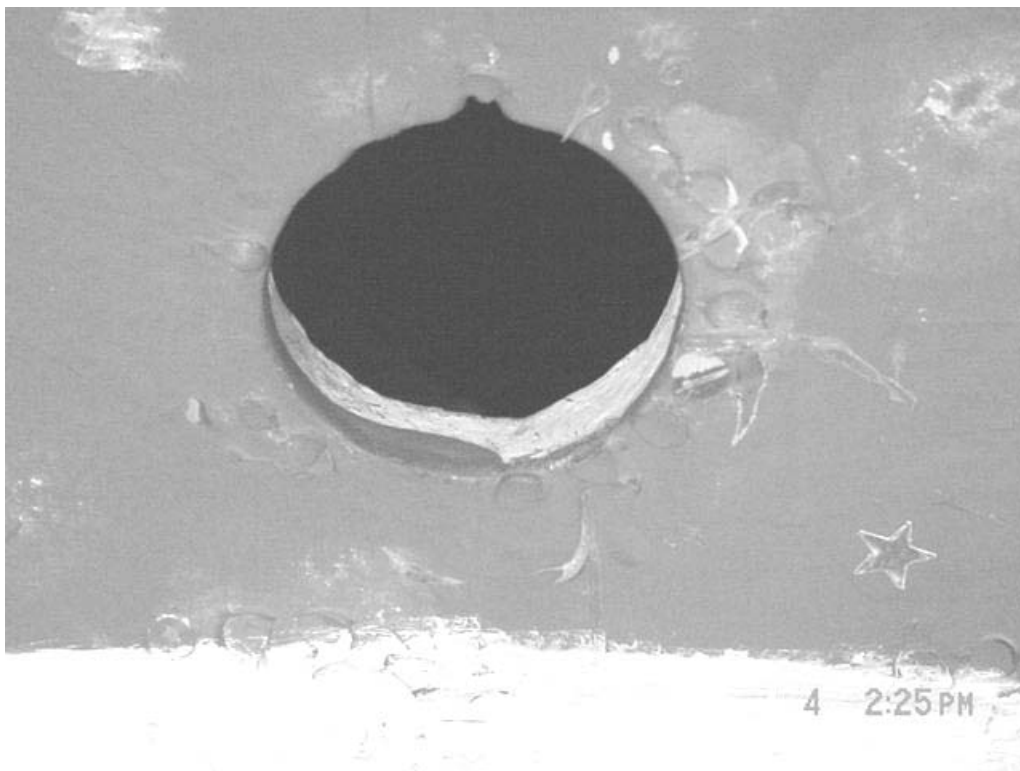
Picture 26

Open Hole in Art Room Wall

12. Remove or reorganize stored materials to allow easy access to abandoned utilities in the kiln room.
13. Replace missing ceiling tiles and seal utility holes (e.g., art rooms, kiln room); to prevent the egress of drafts, odors and particulate matter into occupied areas.

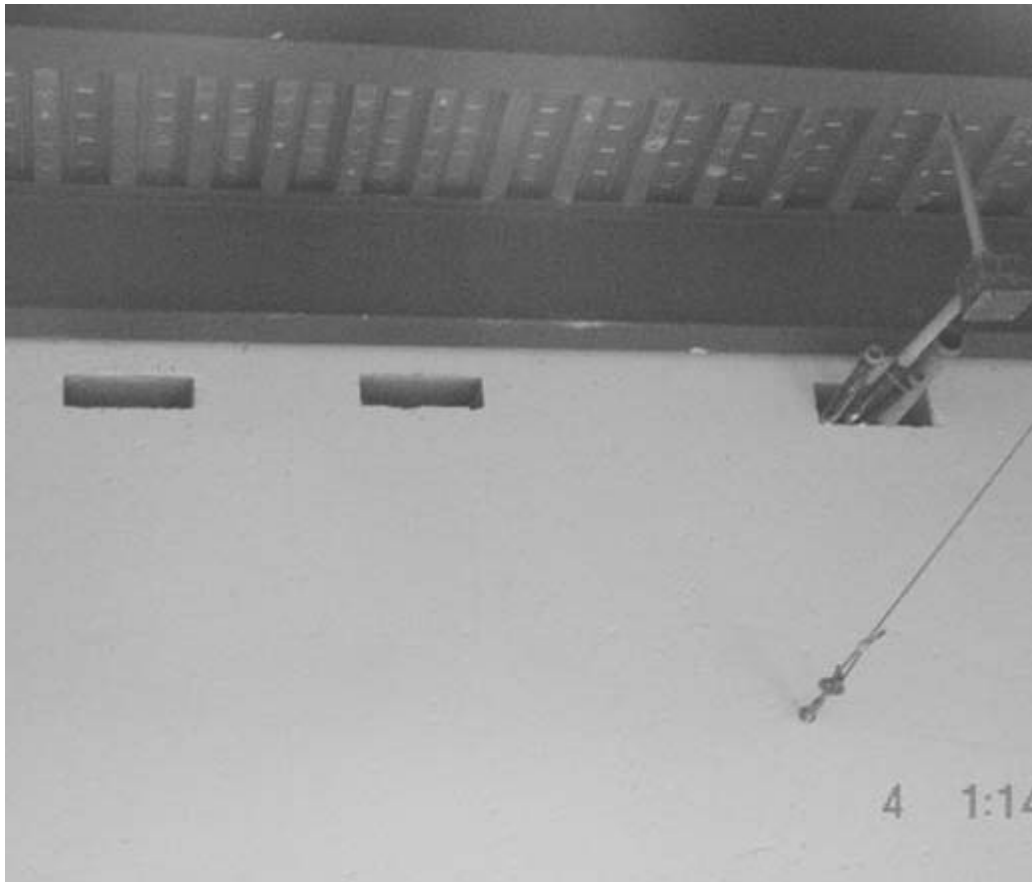
Picture 27

Holes in Auxiliary Gym Wall

14. Replace missing blocks or seal holes in auxiliary gym wall and seams around the edges of the floor to mitigate musty odors.
15. Re-wrap damaged fiberglass insulation around pipes in art rooms and other areas.

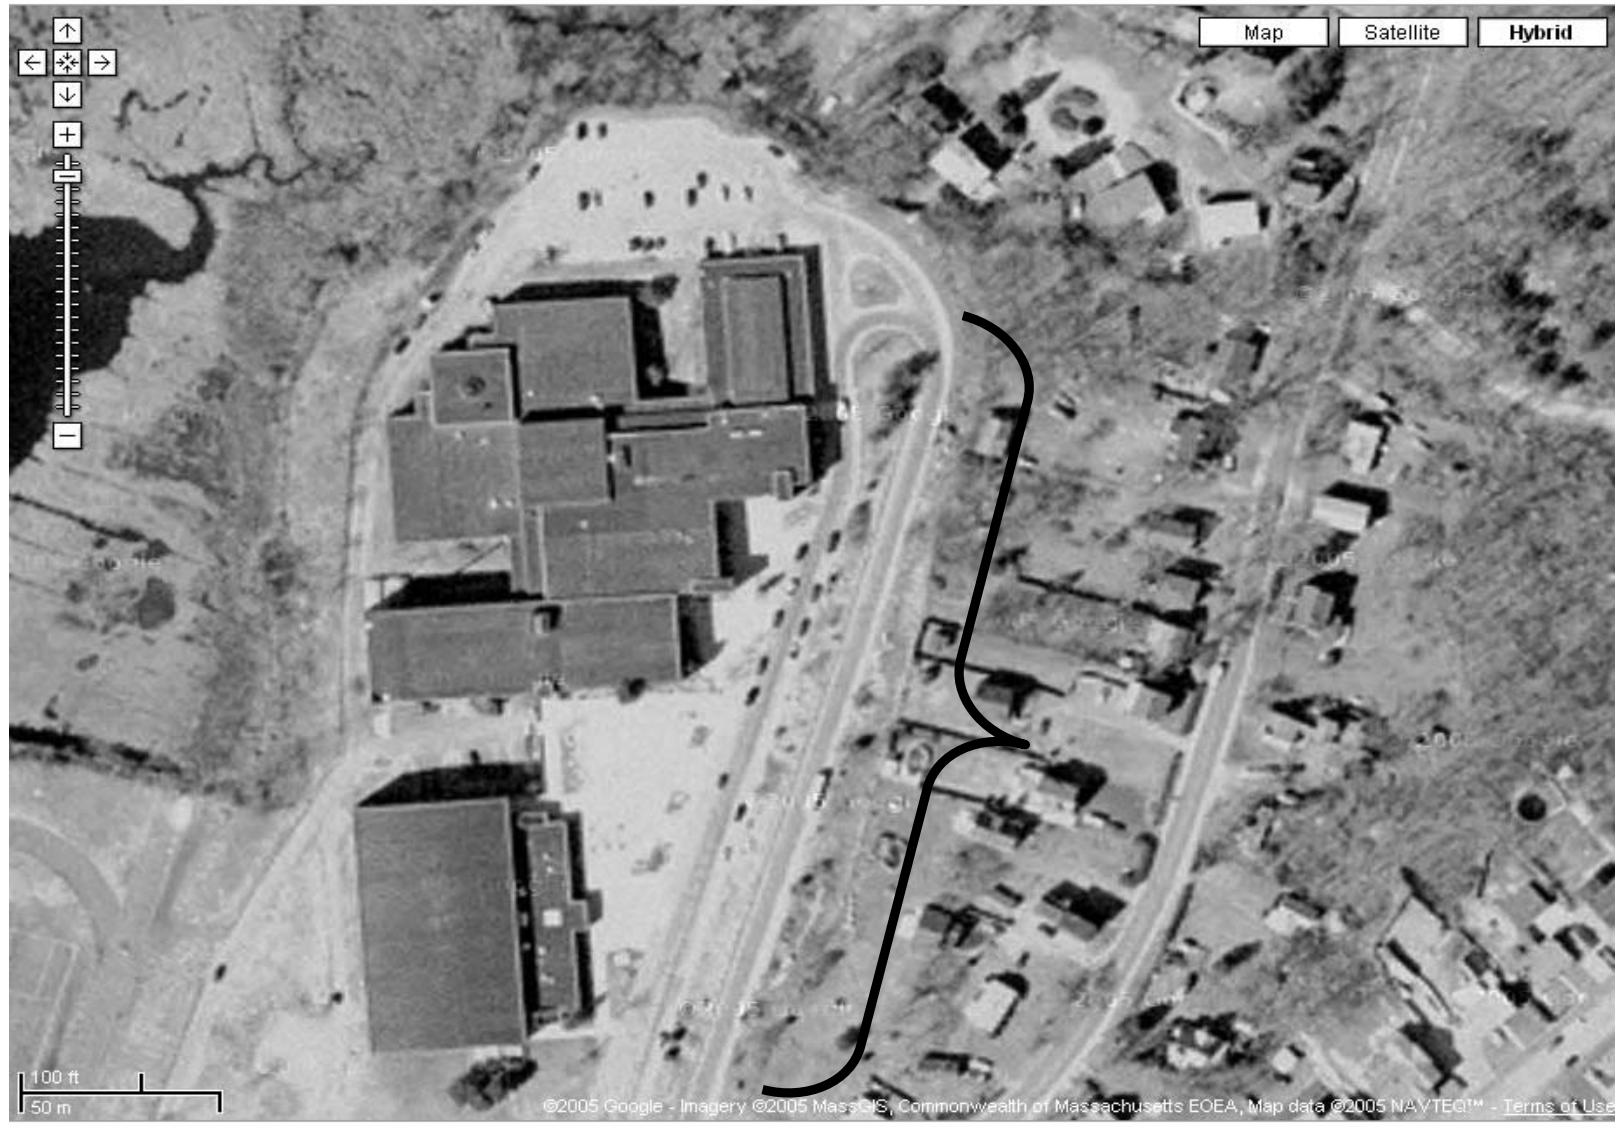
Figure 2
Aerial View O'Maley Middle School

Several other conditions that can affect indoor air quality were noted during the assessment. The OMS has experienced periodic issues with entrainment of vehicle exhaust. Several observations may help to explain this. First, the student drop off area is located directly in front of the building (Figure 2); when busses and cars idle in this area (even if only for a short time) it presents the opportunity for exhaust emissions to be drawn into univent air intakes located along the front of the building. The second factor relates to the area terrain. The access road runs parallel to the building, which leads to a hairpin turn and travels directly in front of the building (Figure 2). The hill creates a trough along the front of the OMS, which is set in a bowl-shaped area next to the hill. Under certain wind and weather conditions the low lying area

**Note Access Road on Hill and Hairpin Turn Parallel to School which forms a “Basin”
Between the Hill and Building**
